Traditional Craft Skills as a Source of Historical Knowledge

Reconstruction in the Ashes of the Medieval Wooden Church of Södra Råda

Gunnar Almevik & Karl-Magnus Melin

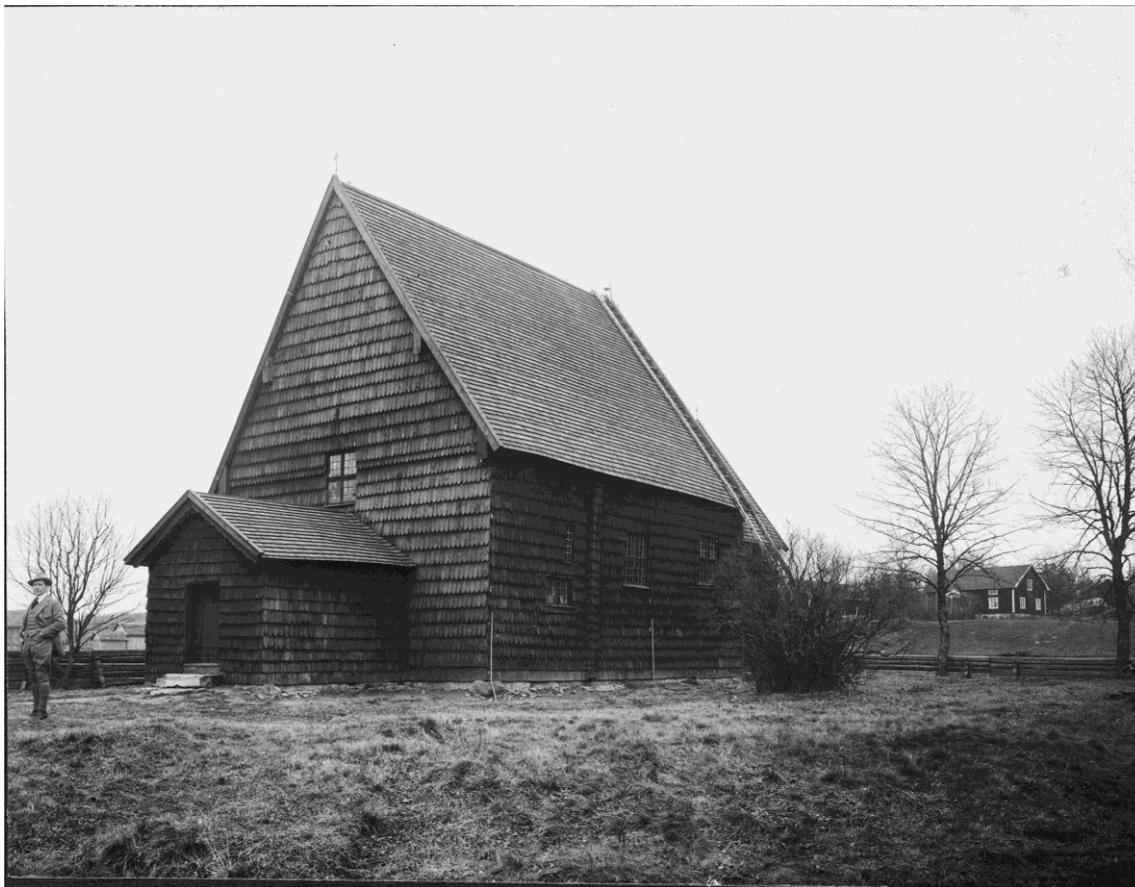
Fig. 3. Södra Råda. Photo ATA.

The parish of Södra Råda, to which the medieval church once belonged, is part of the Diocese of Skara (Fig. 3). It is located in the Municipality of Gullspång in the province of Värmland and the administrative region of Västra Götaland. In 1858 a new stone church was built in the parish, and the old wooden church was taken out of use. When the open-air museum of Skansen in Stockholm was established, plans were made to disassemble the wooden church and re-erect it there. The initiative was contested and led to protests from local inhabitants, and the church was finally preserved *in-situ* as a museum.

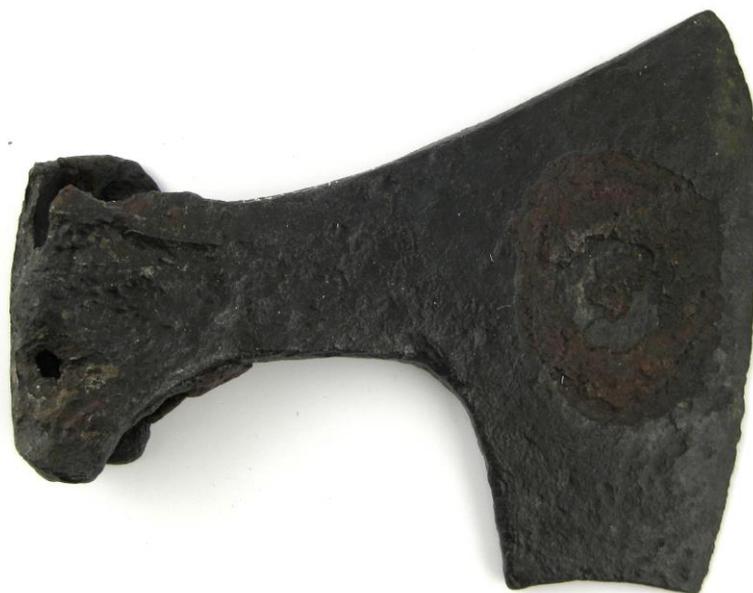
Fig. 6. Axe from Lödöse (Lödöse Museum, inv.no. 27600:443:H:345). One of the initial investigations concerned hewing techniques in the Södra Råda and Hammarö churches and finding axes in museum collections that corresponded in age and resulting tool marks.²⁷ The axe from Lödöse was found in 2010 and is of a type hitherto

found in nine specimens, from Denmark in the south to Lödöse in the north. Two of these axes have been stratigraphically dated to the period 1300–1350, and the axe from Lödöse has been dated to the period 1200–1400. The axe, which was copied for use in the reconstruction, is well balanced and works well for hewing the timbers (*sprätthuggning*) and the making of medieval-type shingles. Photo Karl-Magnus Melin.

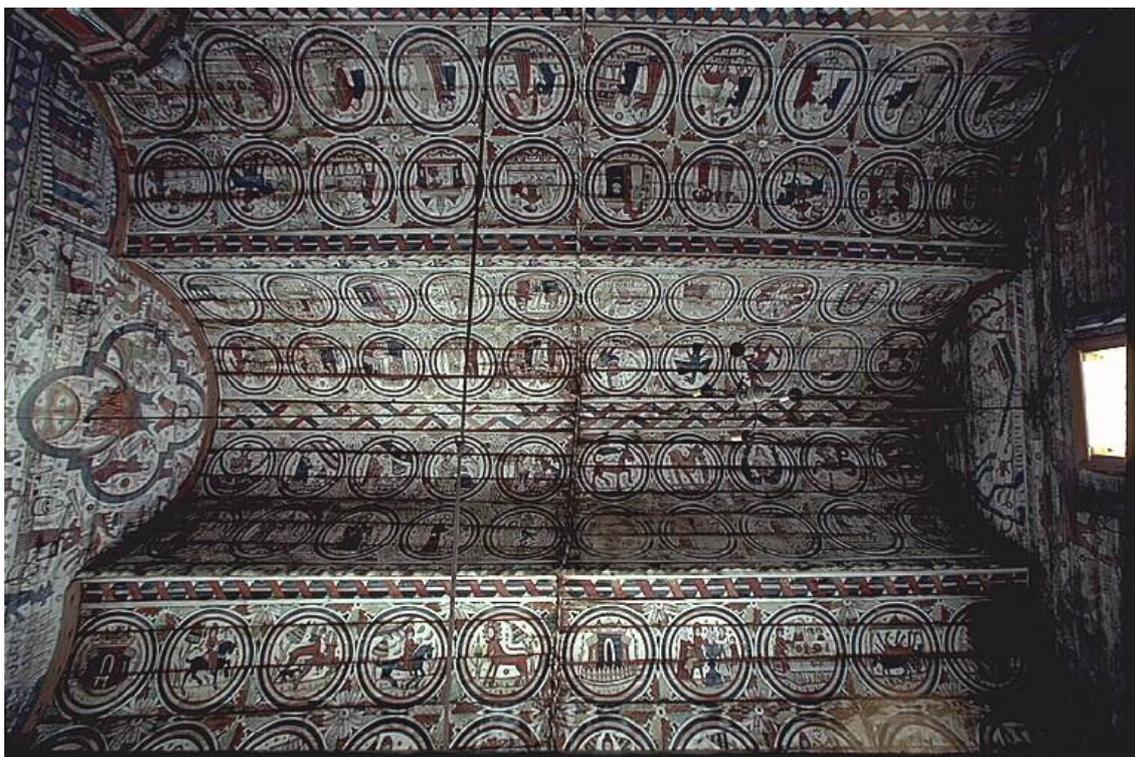
Fig. 7. The trefoil of the nave at Södra Råda. In the middle of the nave, the boards are jointed and this seam is hidden by a carved rope moulding. We have examined photos of the boards in the Södra Råda church, and all of the boards are approximately 6 metres long. Photo National Heritage Board, ATA.

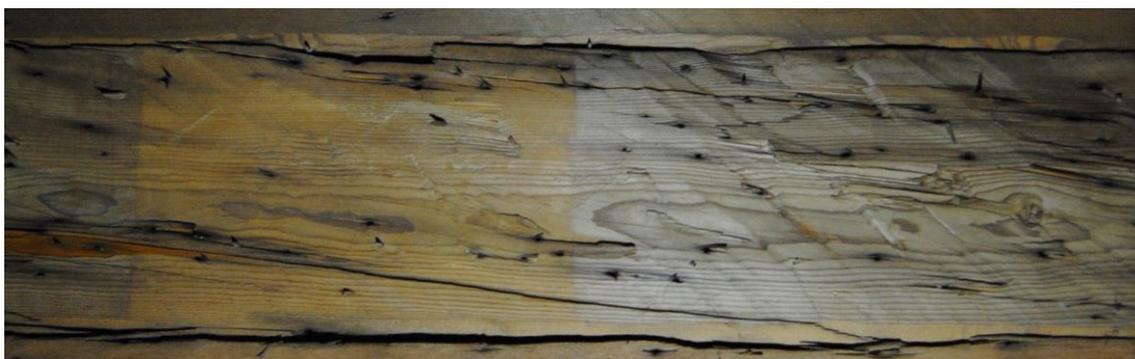
Fig. 9. Roof board from the Tångeråsa church. The board has very warped fibres. It was necessary to use a controlled cleaving technique to succeed with a tree like this. This type of material was tested, with good results, in the practical experiments. Photo Christina Persson.

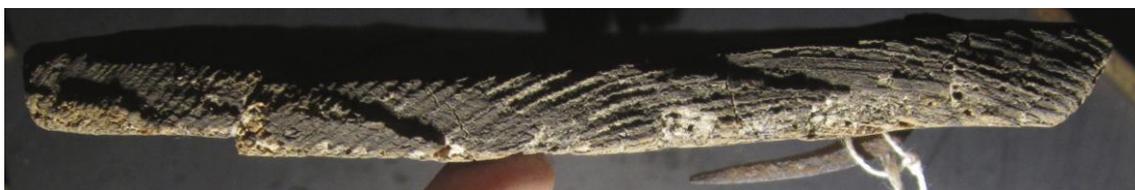
Fig. 10. Cleaved board from the Hammarö Church. The Hammarö church trefoil board SHM 23700:6. Note the almost horizontal growth rings, which strongly indicate that four boards were produced from one timber. Photo Karl-Magnus Melin.

Fig 22. Board from a practical experiment. An outer cleft board from experiments in February 2013, very similar to the board SHM 23700:6 from the Hammarö church. Photo Karl-Magnus Melin.

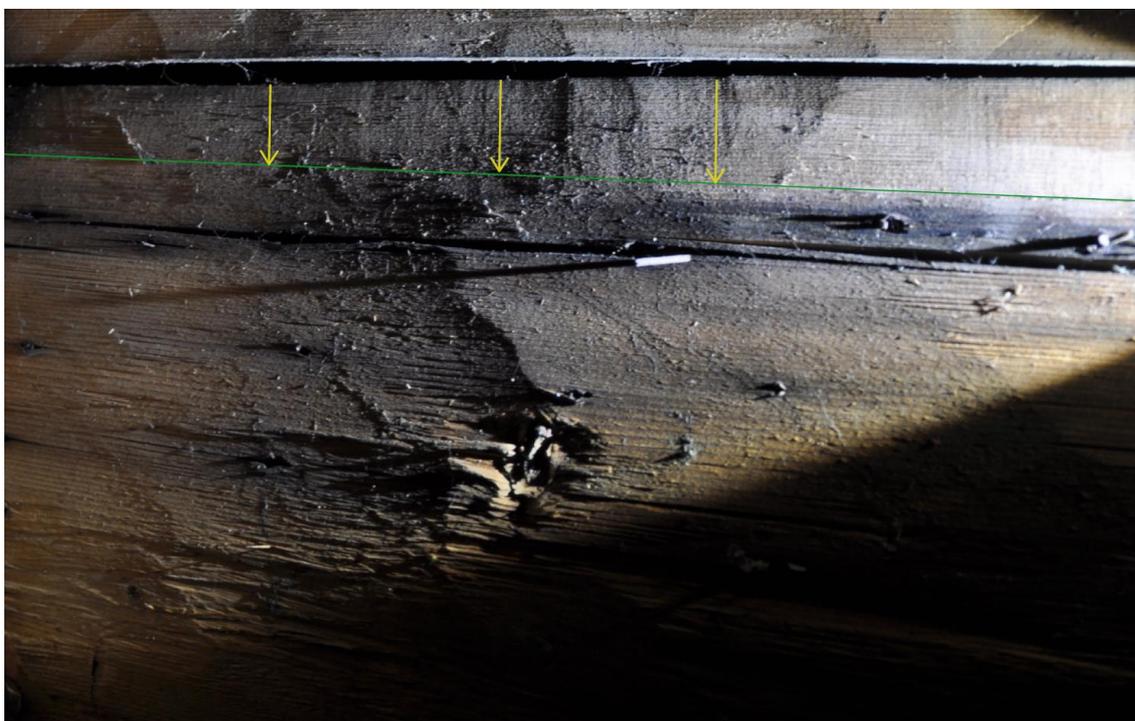
Fig. 12. Traces of *spårning*. In the Sjösås church, Daniel Eriksson has documented tool marks from *spårning* on a cleaved roofing board. Usually these marks were cut away in the later steps of the *sprätthuggning* process. The yellow arrow shows the direction the axe was driven down plumb, and the green line shows the depth of the *spårning*. Photo Daniel Eriksson.

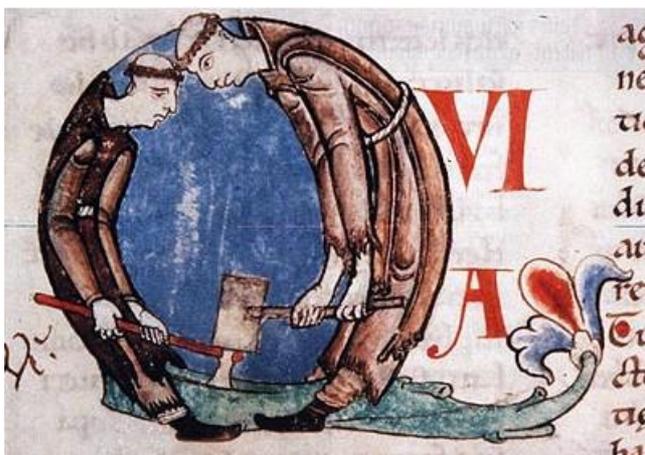
Fig. 13. *Spårning* and cleaving. This picture from a twelfth-century Citeaux manuscript of the *Moralia in Iob* (Dijon, Bibliothèque municipale, 170; Wikimedia Commons, https://commons.wikimedia.org/wiki/Category:Moralia_in_Iob_of_Citeaux#/media/File:Cistercian_monks_cleaving.jpg) has been used to illustrate cleaving.⁴⁵ We interpret that the picture actually shows monks in

the process of *spårning*. The picture can be compared with the description made by August Holmberg. Note that they used a mallet to hit the axe in order to have full control and gain more power.

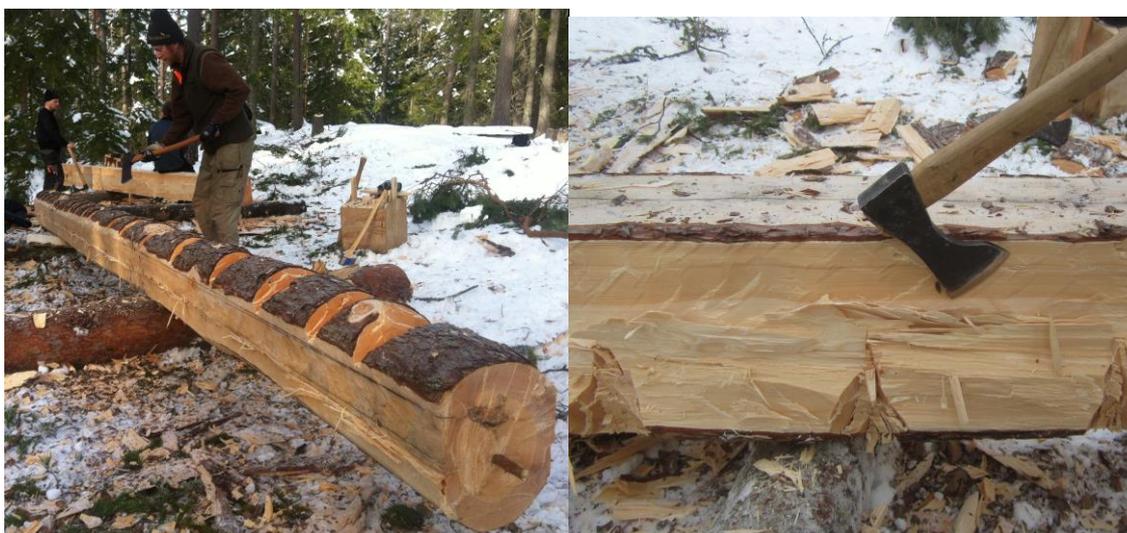
Figs. 15–16. Boxing the log. To box the logs, first the corners were marked with soot lines and then the log was turned and scores were made about one to two feet apart, almost touching the soot lines. Then the log was turned back and the segments were cut and cracked away (*klamphugg*). Photos Ola Hugosson and Karl-Magnus Melin.

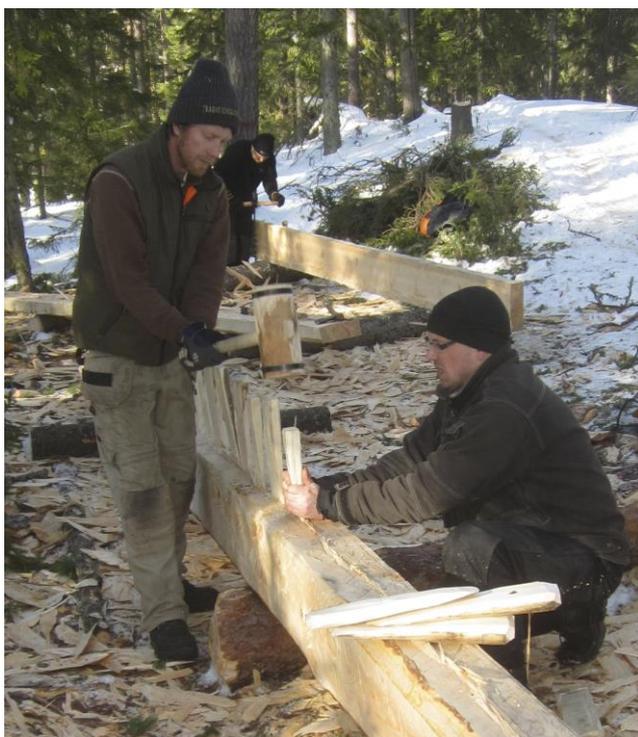
Figs. 17–18. Use of wedges and *spårning*. After initial *spårning*, a lot of wedges were used to get an even pressure. After a while we could concentrate more on *spårning* and used fewer wedges. The wedges we used were made of aspen. A good width of the wedges is two to three inches and thickness around one and a half inches, and the length approximately twelve inches. Photos Karl-Magnus Melin.

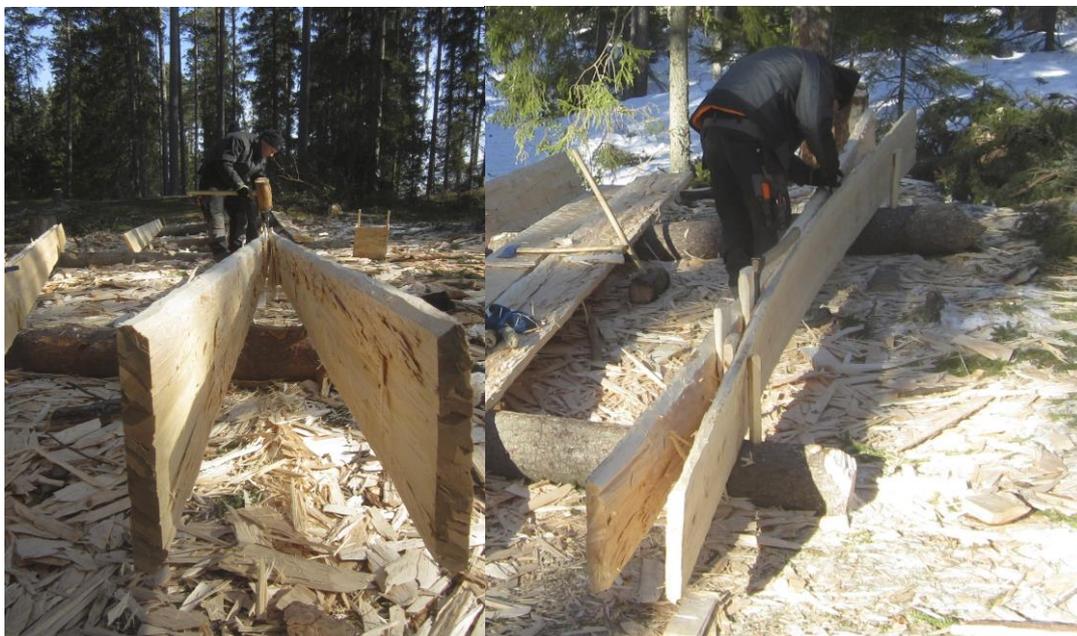
Fig. 19–20. Grooving. The cleaving technique was improved by making a v-shaped groove. Remains of the groove can be seen in the picture. The grooving was only done on the second (tangential) cleaving in order to minimise the risk of cracking the thin boards produced. In the picture on the left, the cleaving is made from one end to the other. The one on the right shows the cleaving made from both ends simultaneously. In the experiments made in 2014 and 2015 we have rationalized the grooving procedure away since we on these later occasions did not cleave frozen wood. Photos Karl-Magnus Melin.

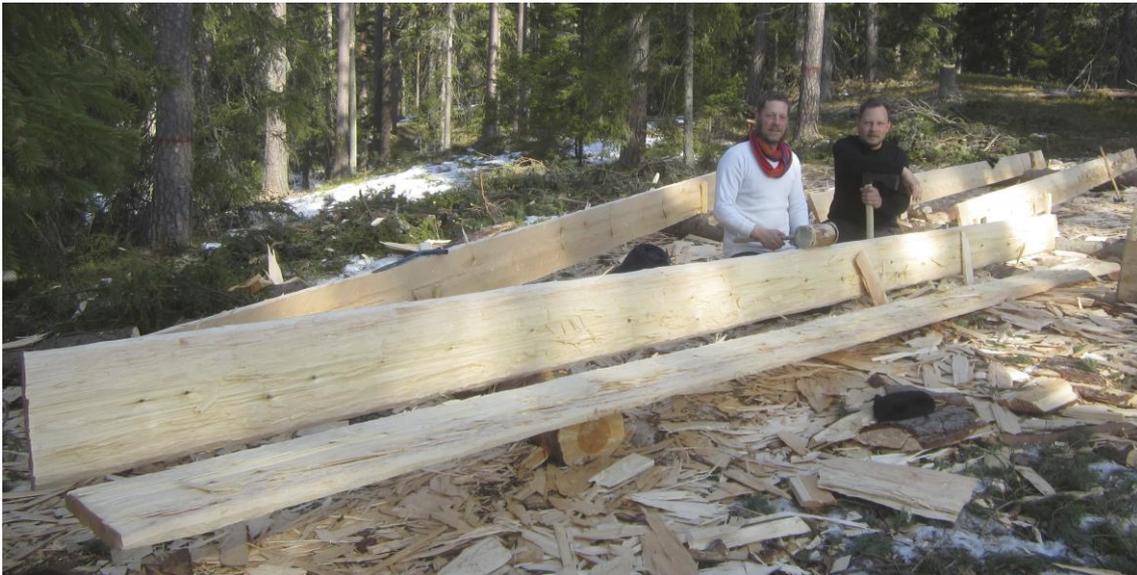
Fig 23. Boards resulting from a successful cleaving. Note that all of the boards are of the same length in all photos. Photo Mattias Hallgren.

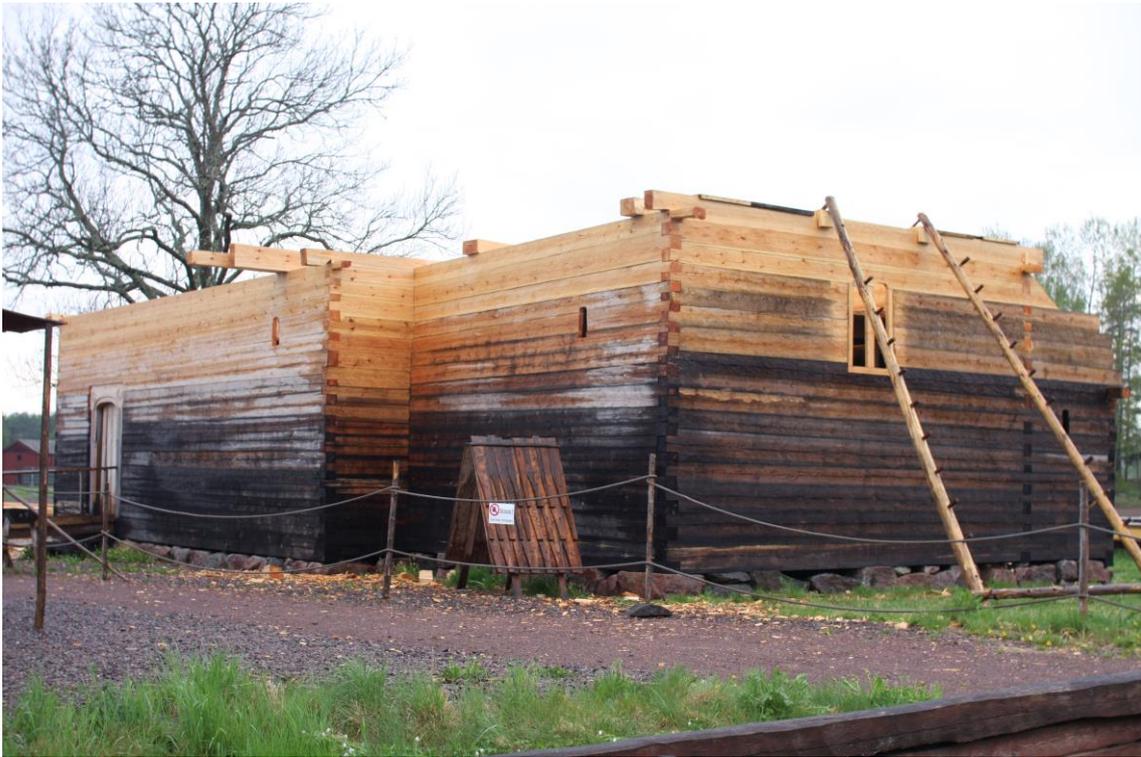
Fig. 25. The reconstruction in 2013. The nave and chancel timbered to the level of the sacristy, where the cleaved boards are placed. Photo Karl-Magnus Melin.
